INDOOR AIR QUALITY ASSESSMENT

**Haverhill City Hall, Room 310
4 Summer Street
Haverhill, MA**

Prepared by:
Massachusetts Department of Public Health
Bureau of Environmental Health
Indoor Air Quality Program
October 2016

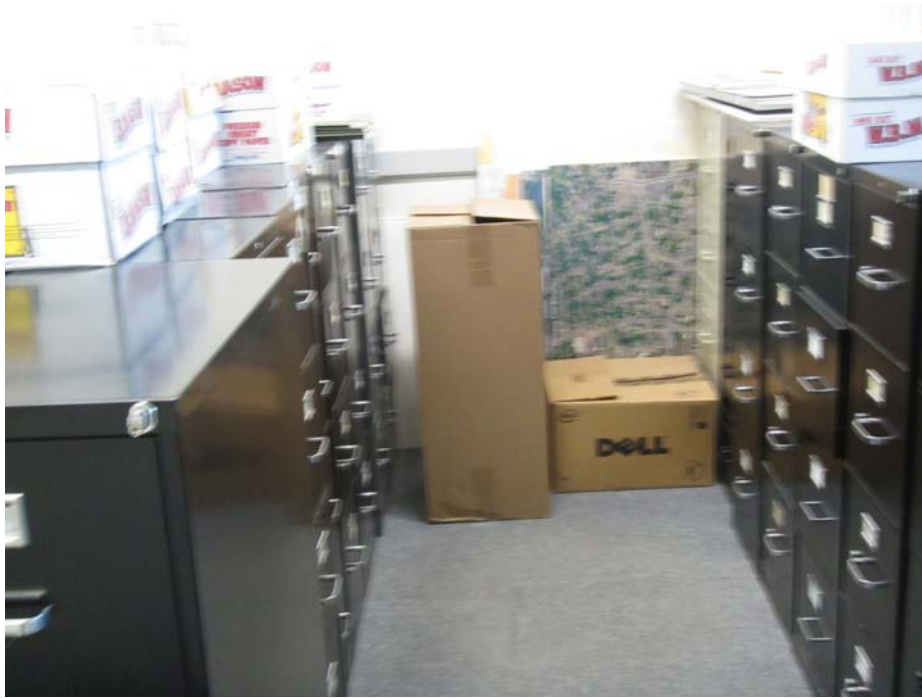
Picture 1

There were a large number of file cabinets stored in this office area (Picture 1). Items originally stored in unconditioned areas such as basements should be examined for signs of water damage and odors prior to being brought into occupied areas. Any files/boxes found to be water-damaged should be scanned/copied and discarded since porous items not properly dried after becoming moistened can become colonized with mold. BEH staff did not observe any water-damaged files/boxes nor were any musty odors or microbial colonization detected at the time of the assessment.

File storage area

1. Clean dust/debris from window wells regularly to avoid aerosolizing particulate matter.
2. Any files/boxes found to be water-damaged should be scanned/copied and discarded to avoid colonization with mold. Extra care should be given to avoid transferring water-damaged files from unconditioned areas (e.g., basement) to occupied areas.

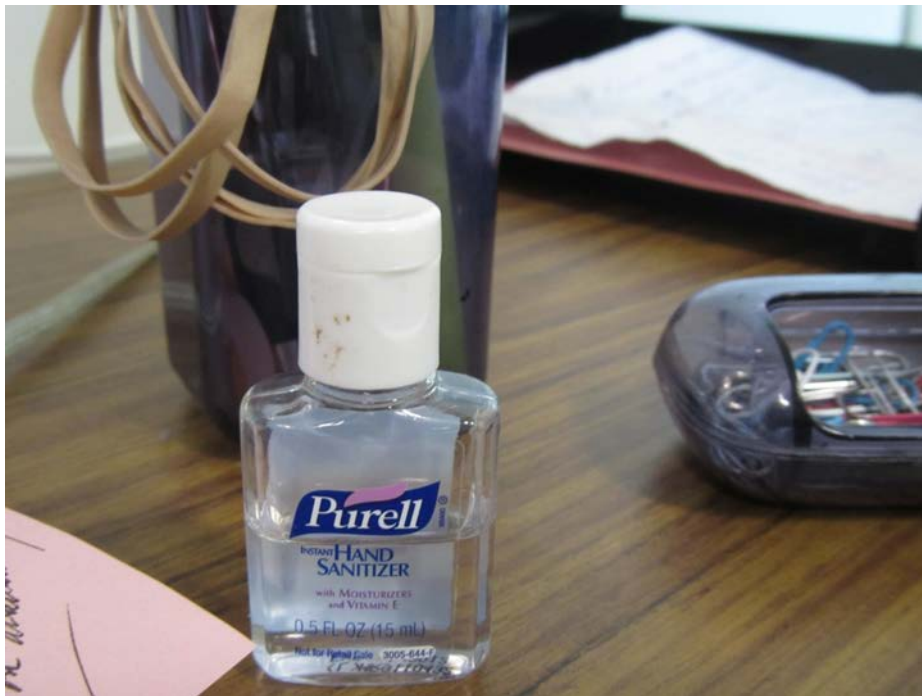
Picture 2

Hand sanitizer with fragrance

3. Eliminate/reduce the use of hand sanitizers, fragrances, and dry erase materials in the office since all of these products have the potential to be irritants to the eyes, nose, throat, and respiratory system of sensitive individuals.

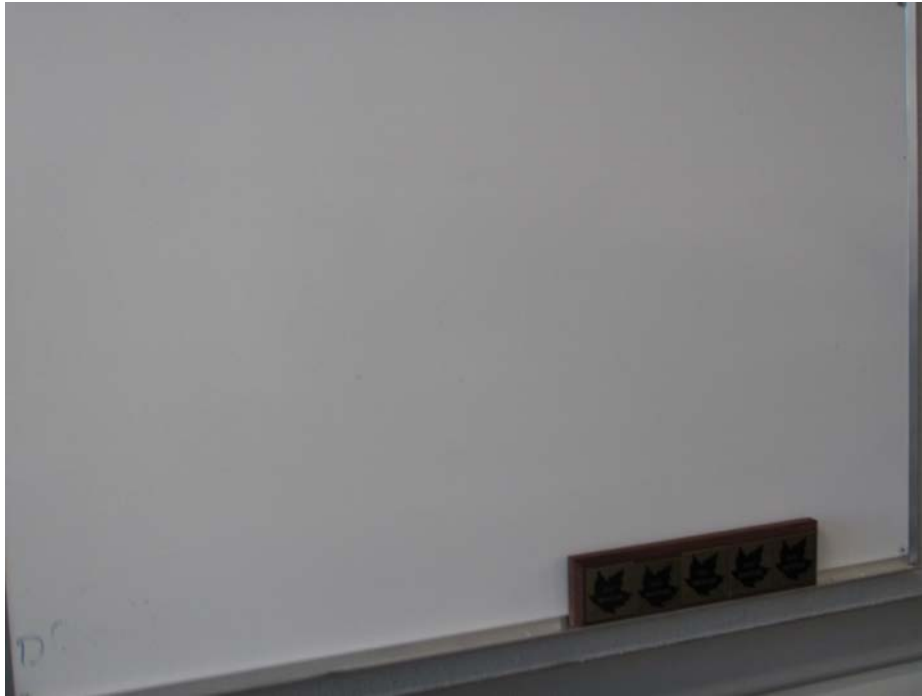
Picture 3

Dry erase board and materials

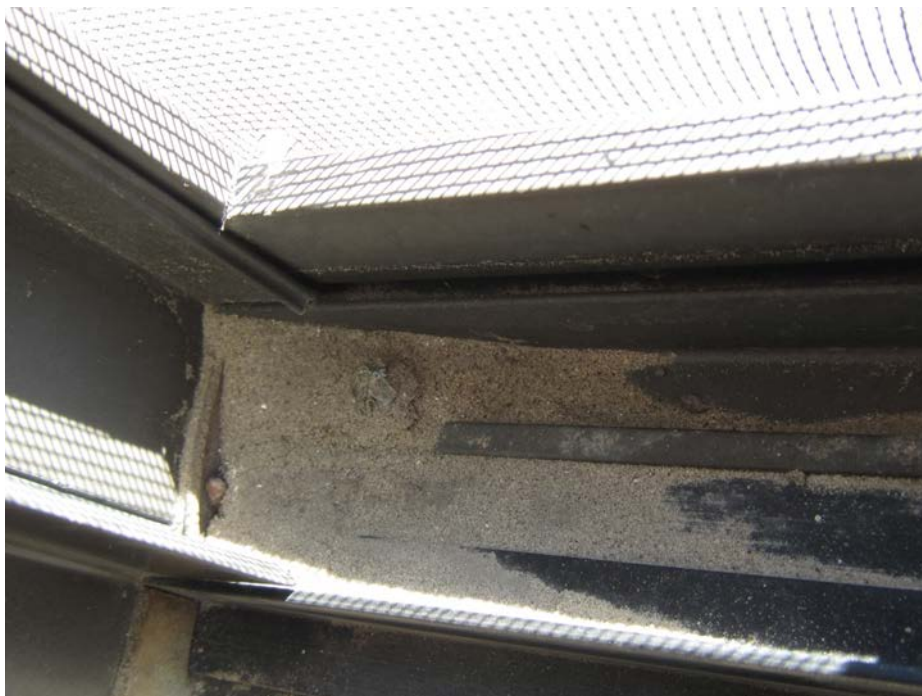
Picture 4

The window of the office suite appeared to have a buildup of dust/debris in the window well (Picture 4). This debris should be cleaned regularly to avoid aerosolization of particulate matter which may have irritant effects to occupants.

Dust/debris accumulation in window well

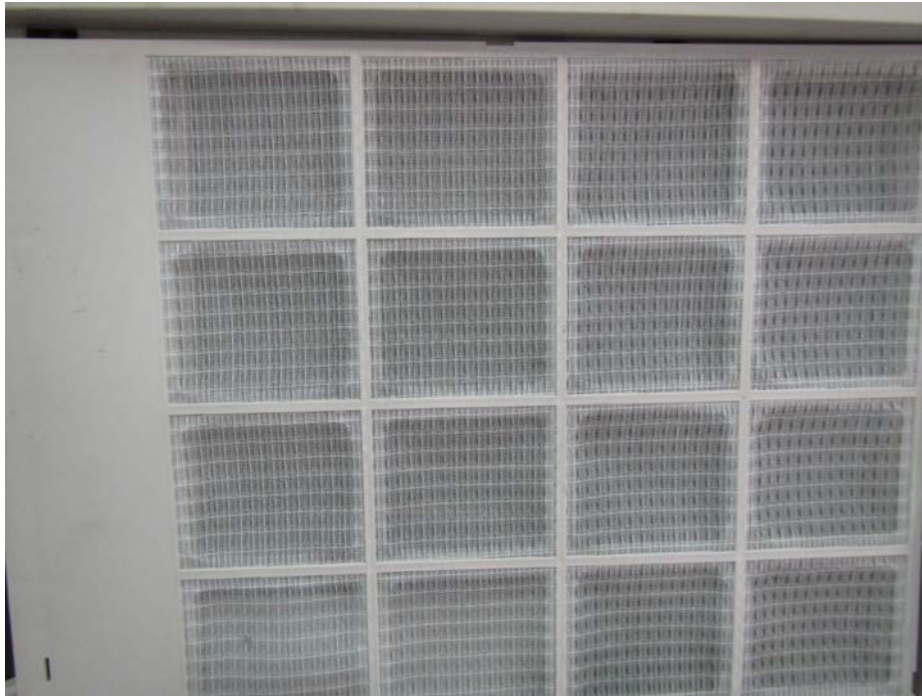
Picture 5

Air conditioning units should be cleaned and maintained according to manufacturer recommendations. The filter in the unit in this office area was noted to be clean and in good repair (Picture 5).

Window AC unit filter

4. Continue to clean and maintain air conditioning unit according to manufacturer recommendations. Use air conditioning unit to keep humidity levels within acceptable levels during summer months and avoid opening windows while unit is in operation.
